3D-Printing for Legacy Component Repair with Hansford Parts & Products

Client:
Hansford Parts and Products

Objective
Remanufacture obsolete 1960s milling machine parts in need of repair after 50 years of use.

Outcome
Employ a hybrid laser engineered net shaping (LENS) process that additively deposits material onto the surface of a steel gear shaft with five broken teeth.

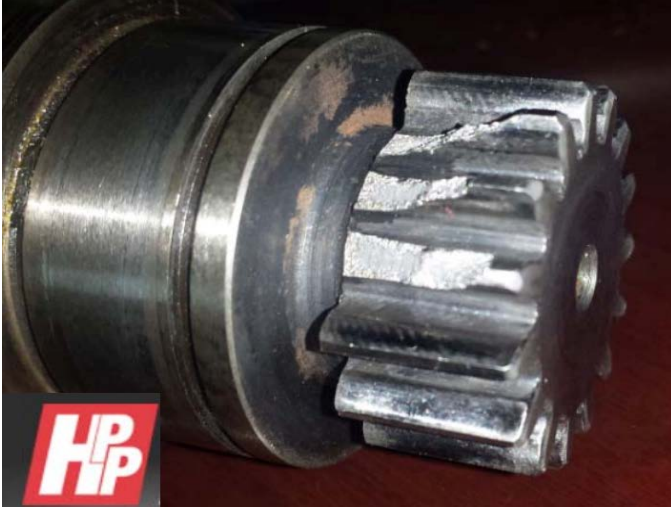
Broken teeth on the machine's drive gear; a total of five (5) teeth were damaged after more than 50 years of use.

The broken gear was part of the mill’s drive shaft, meaning that without it, the machine itself was useless.

Hansford Parts and Products was interested in exploring the capability of additive manufacturing (AM) processes for remanufacturing, and this broken gear shaft provided an opportunity for studying a real-life example. The COE-ASM first assessed whether this gear was a viable candidate for repair via AM. This required an assessment of the existing part's material and geometric properties in relation to the performance characteristics of the available additive manufacturing technologies. Due to the close proximity of undamaged teeth to the repair area, COE-ASM determined that any additive process for repair must allow for precise control. Similarly, the geometric complexity of the part (with multiple diameters across the repair area) meant that the additive process must be capable of working with non-flat and somewhat variable base surfaces. Finally, in this type of application, strength of the repair is critical to the function of the part. COE-ASM performed X-Ray analysis to determine the part's material composition and micro-hardness tests to determine the required strength.

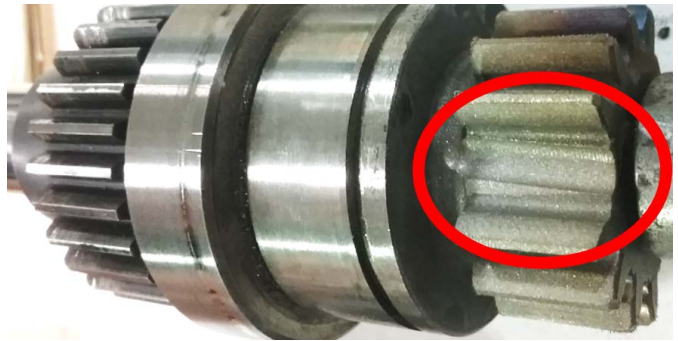
Preparations for LENS repair required machining away the old teeth

After determining the potential for tooth repair with LENS technology, COE-ASM engineers worked with Hansford's own machining specialists to prepare the part for additive repair. This required machining away the broken teeth to create a uniform groove upon which a new tooth could be built, and building a 3D computer model of the gear based on GIS' optical scan of the good teeth to facilitate additive restoration. After this was completed, the part was sent back to COE-ASM for repair. A two-step process was developed, first building up the material to the root of the tooth, and then building up material from which the tooth profile could be machined. A stainless steel material (Grade 420) was used for the repair.

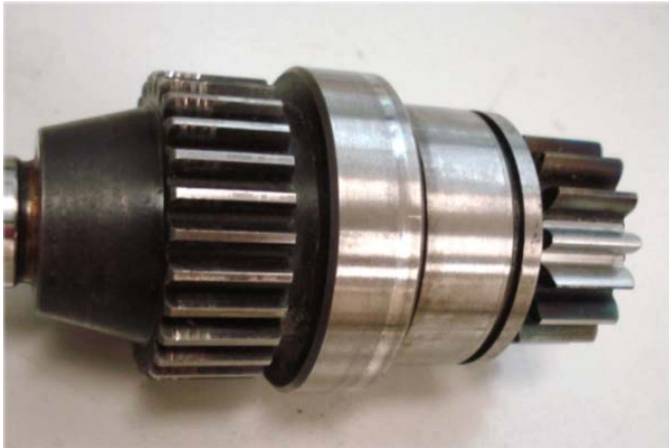
Full photo of final form achieved by machine finishing at Hansford.

After validating hardness and expected performance, COE-ASM returned the repaired part to Hansford, where the company employed its own skilled machinists to finish the additively-repaired teeth into their final form.
